**National Highway
Traffic Safety
Administration**

Case Vehicle (A): 2000 Land Rover
 Type: Discovery II, 4-door SUV
 Driver: 32-year-old male
 CDC: 12-FYEW-3

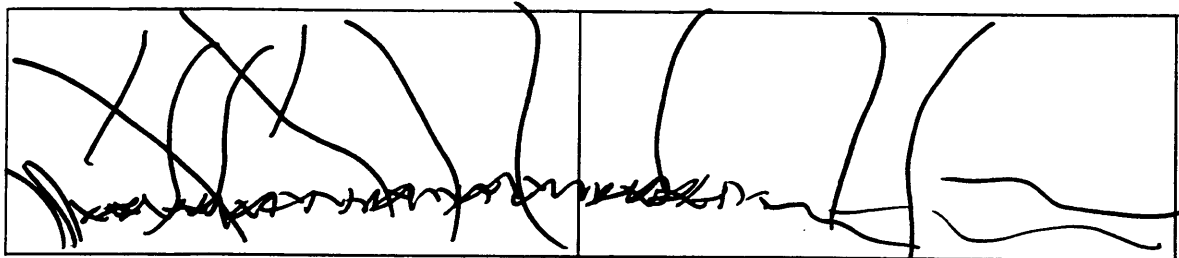
LOCATE AREA OF WINDSHIELD INTEREST OR DAMAGE WITH DIMENSIONS (VERTICAL & HORIZONTAL) ON THIS DIAGRAM OF THE WINDSHIELD AS VIEWED FROM INSIDE.

62
L

56
C
